On-site and environmental effects of soil erosion by wind

Ivica Kisić & Darija Bilandžija

Meteorološki izazovi 3: Ekstremne
vremenske prilike i utjecaj na duštvo.
Zagreb, 21-22.11.2013.

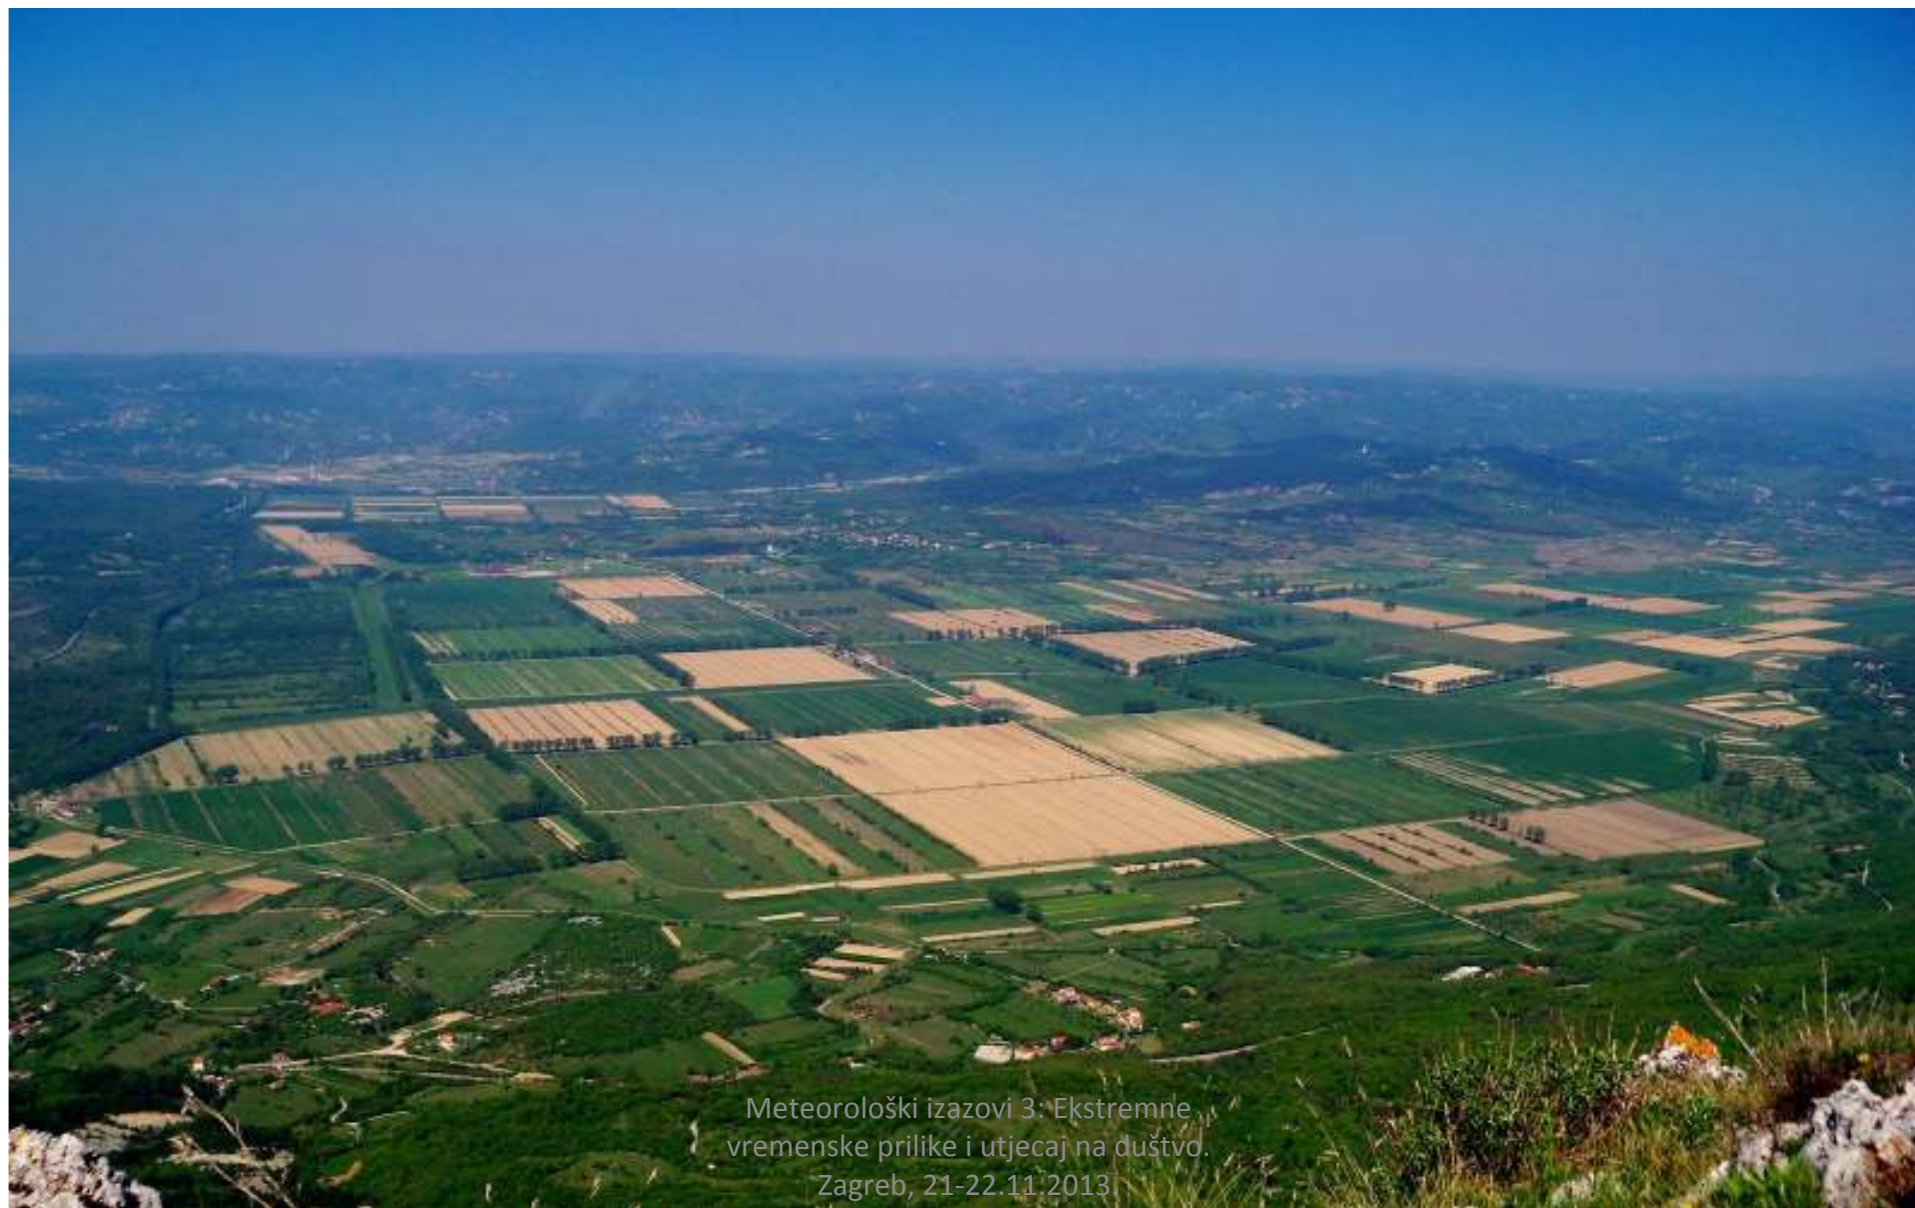
Čepić field, before 2/3 February 2012

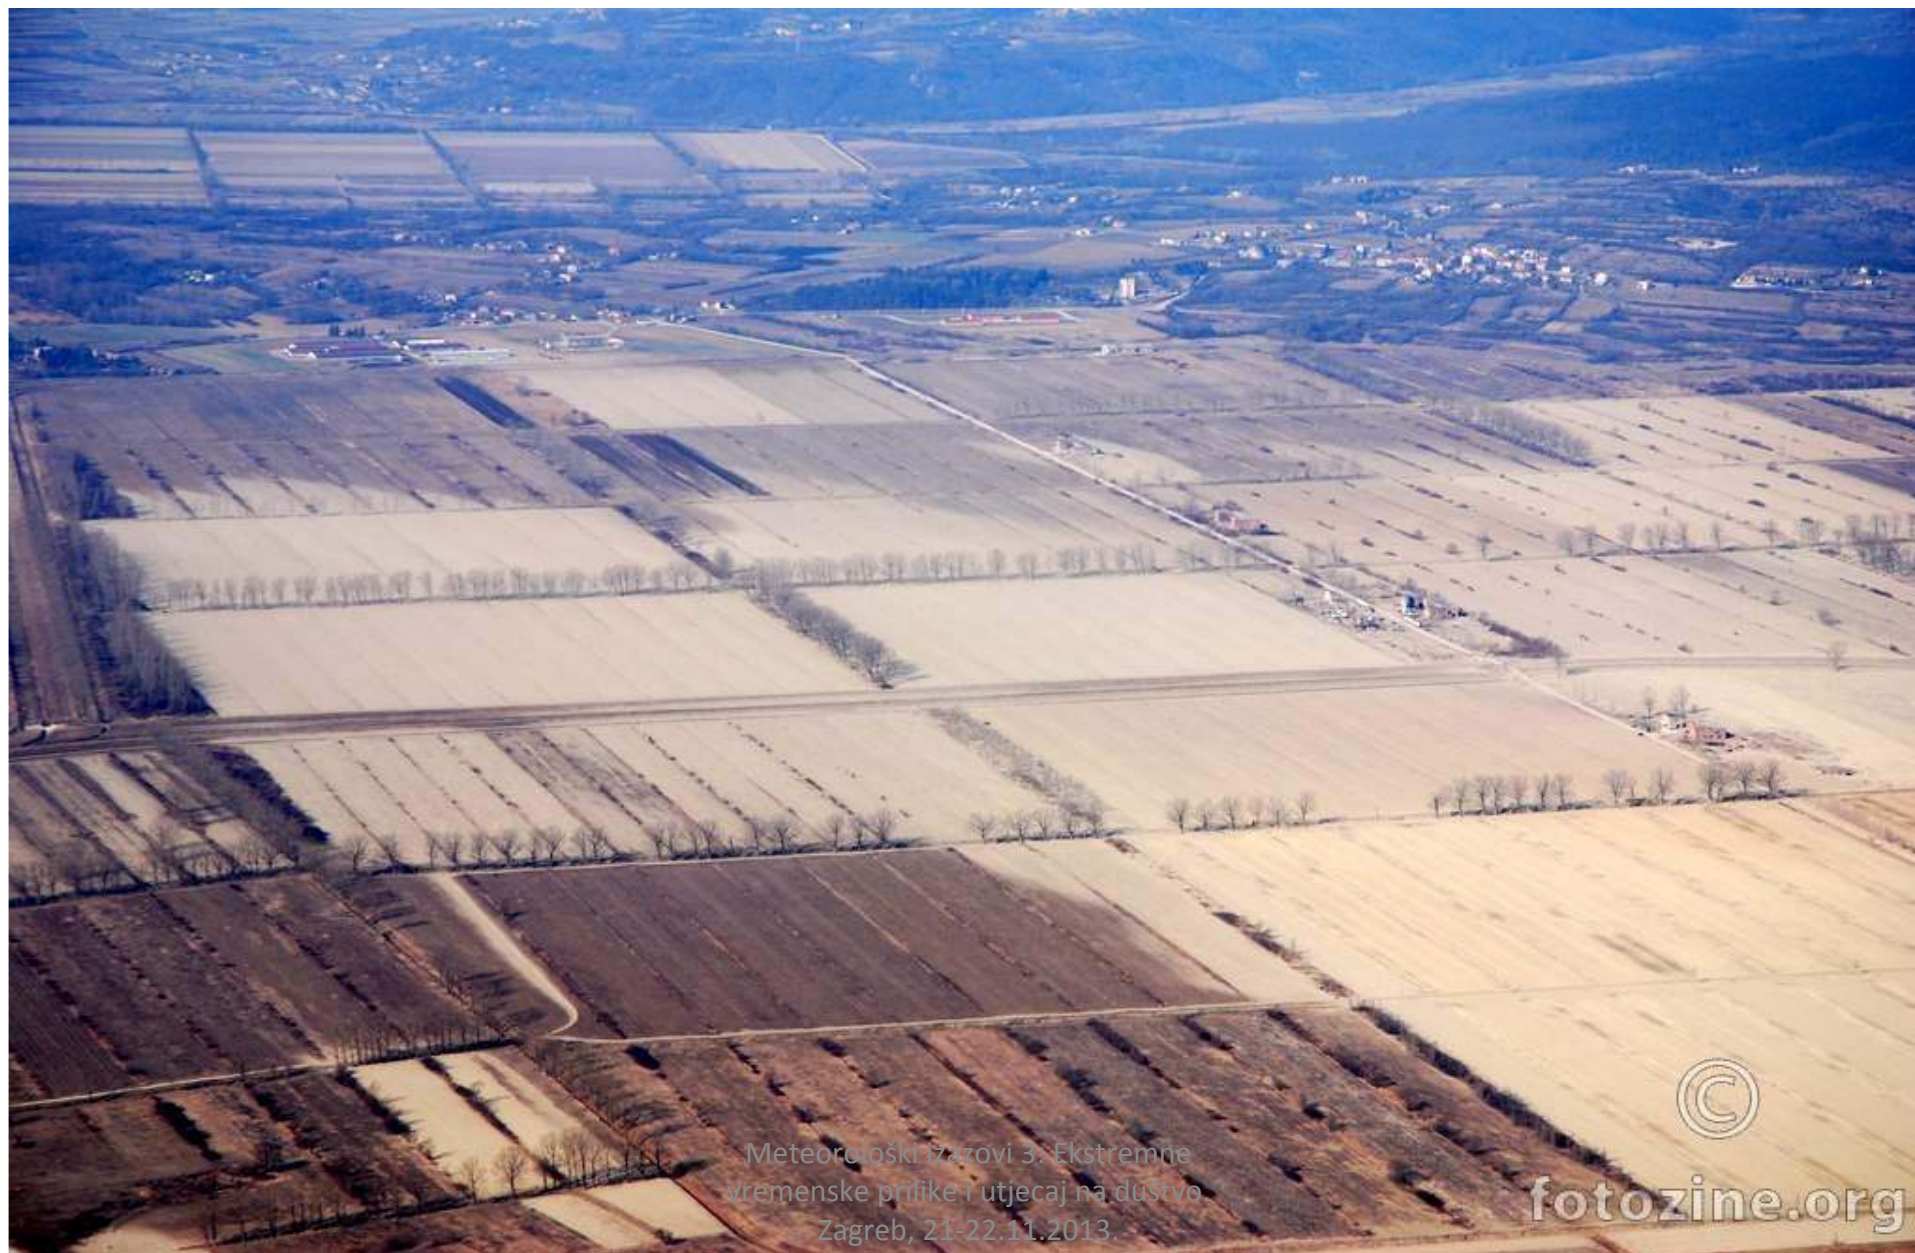
Čepić field, after 2/3 February 2012

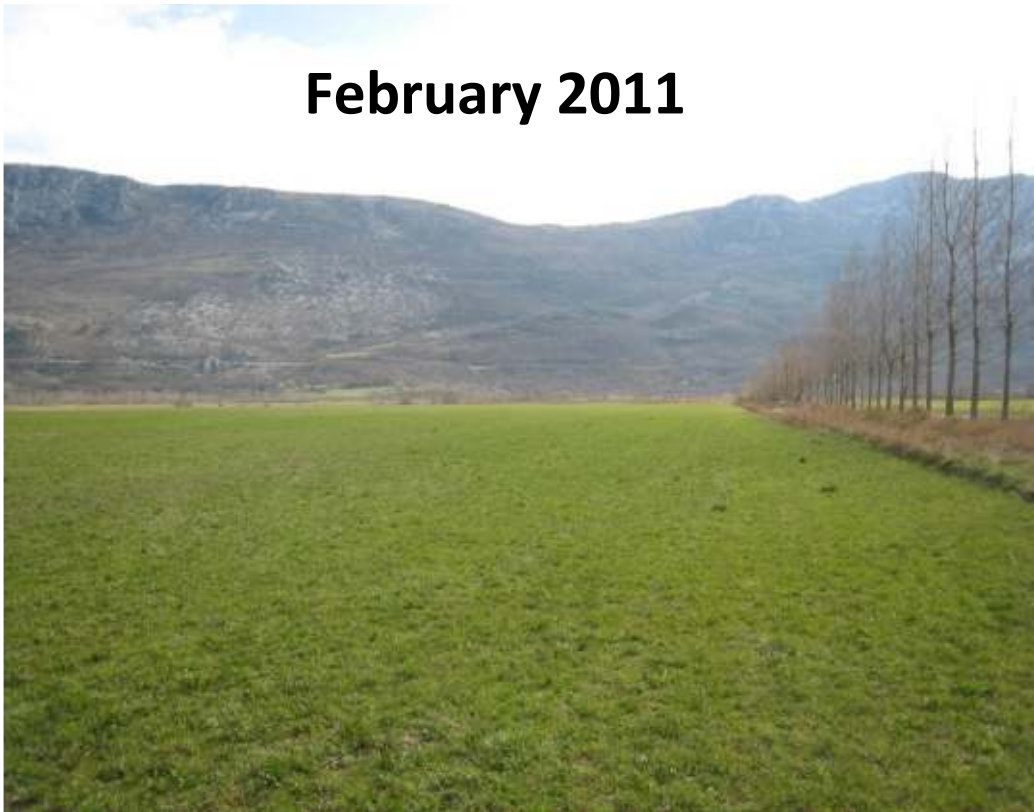
25 cm

February 2011

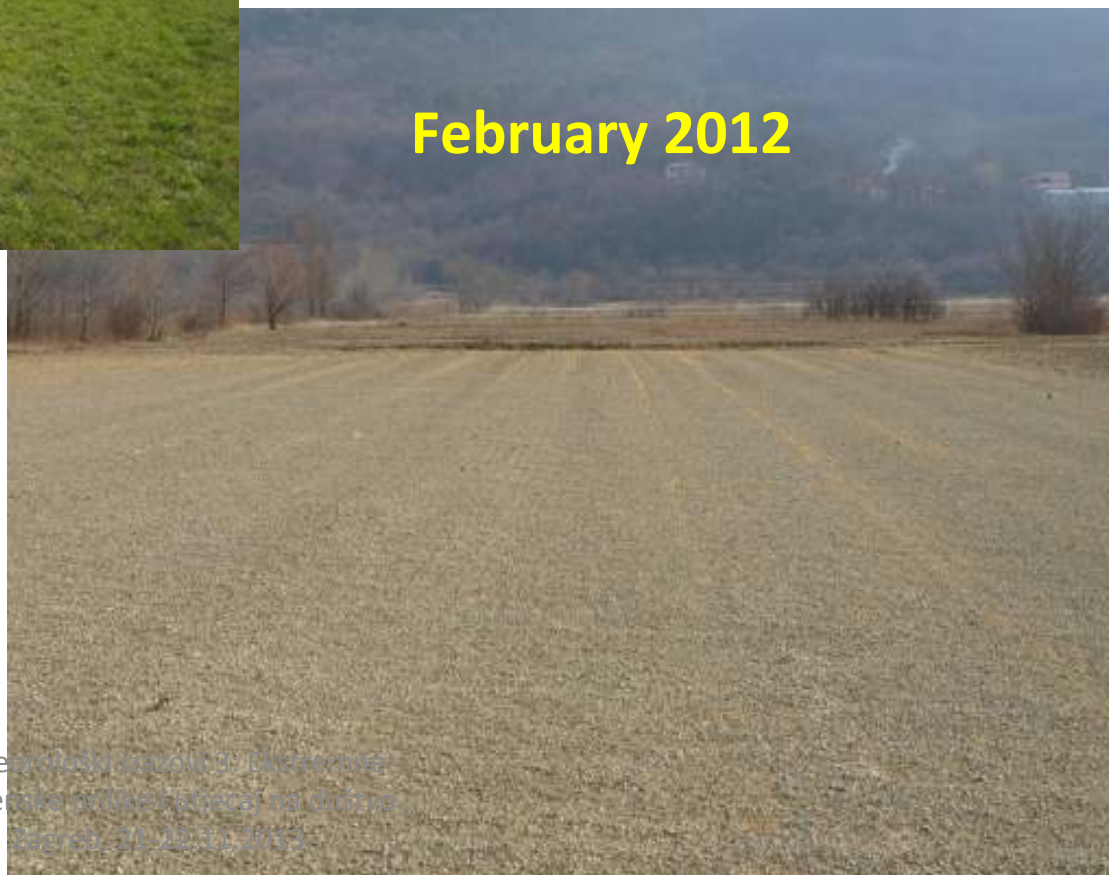
February 2012

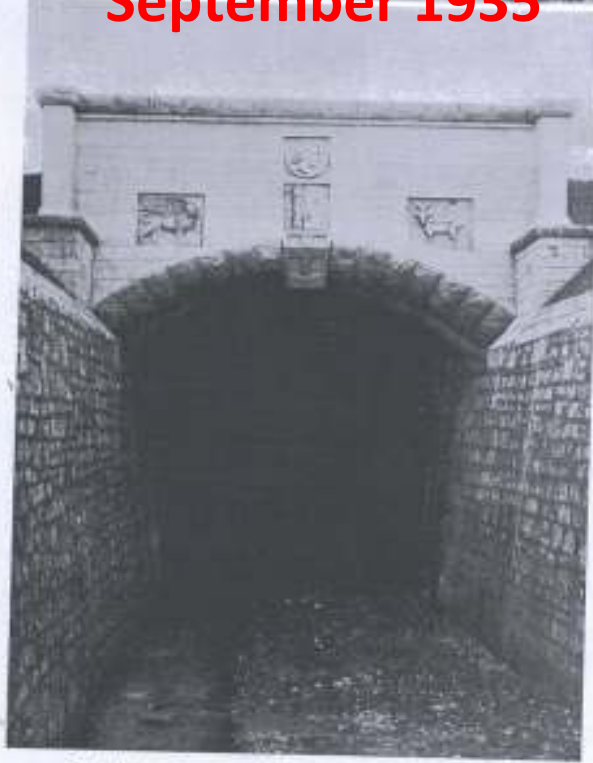
Portale d'imboccatura della galleria prima dello scarico

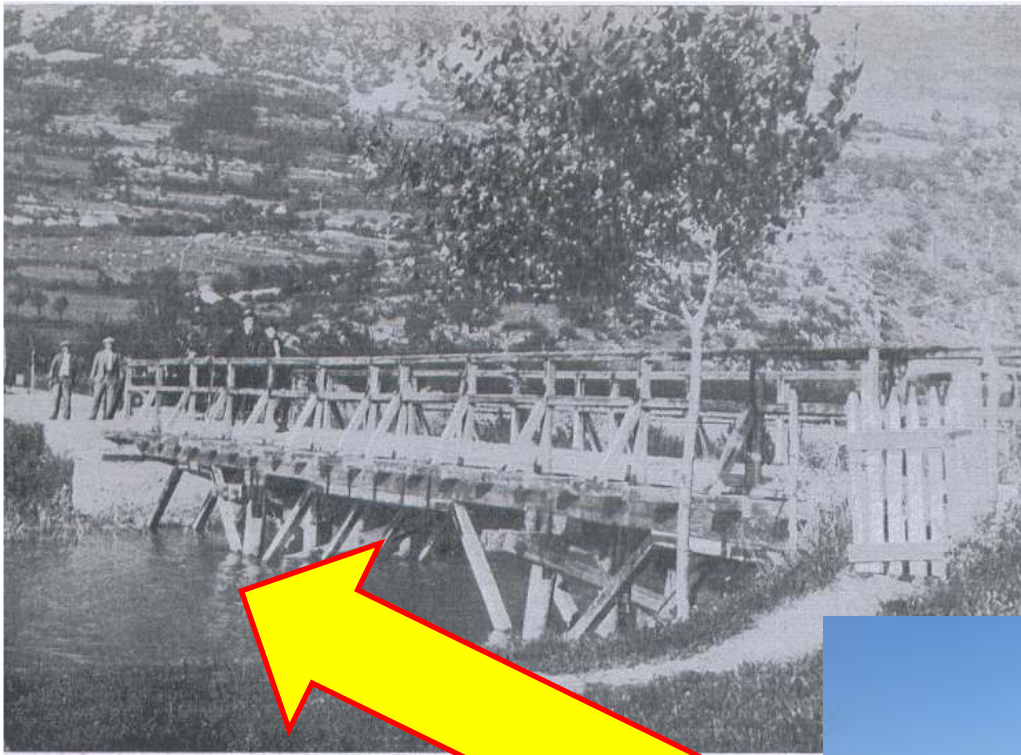
First cause of wind erosion

Year 1934

Ponte sul canale

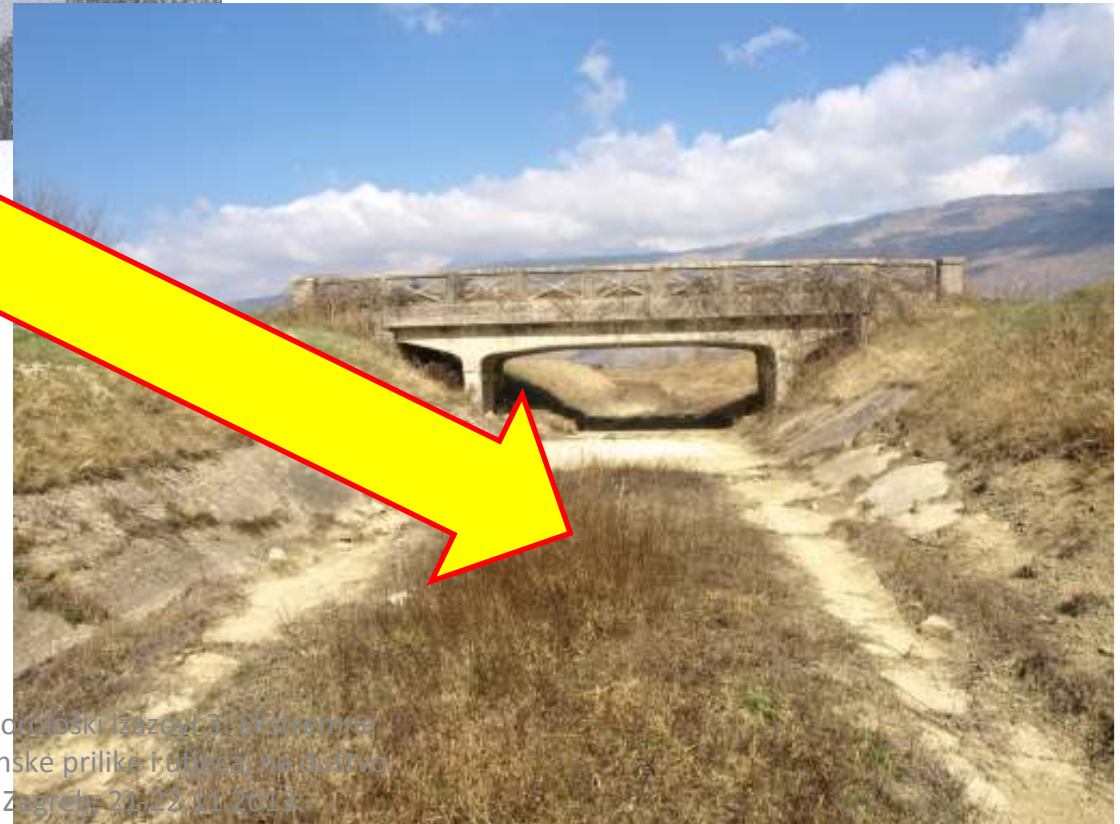
Year 2012

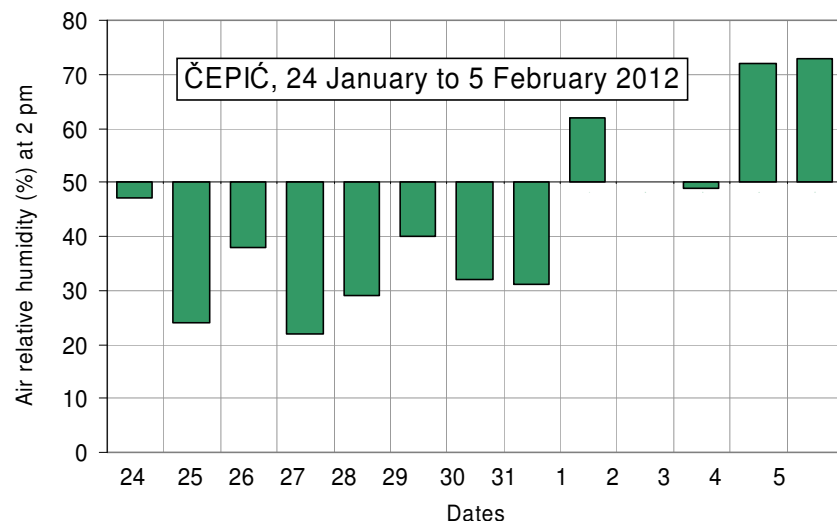
RELATIVE HUMIDITY

In the eight-day period that preceded soil erosion by wind, relative humidity at noon was lower than 50%

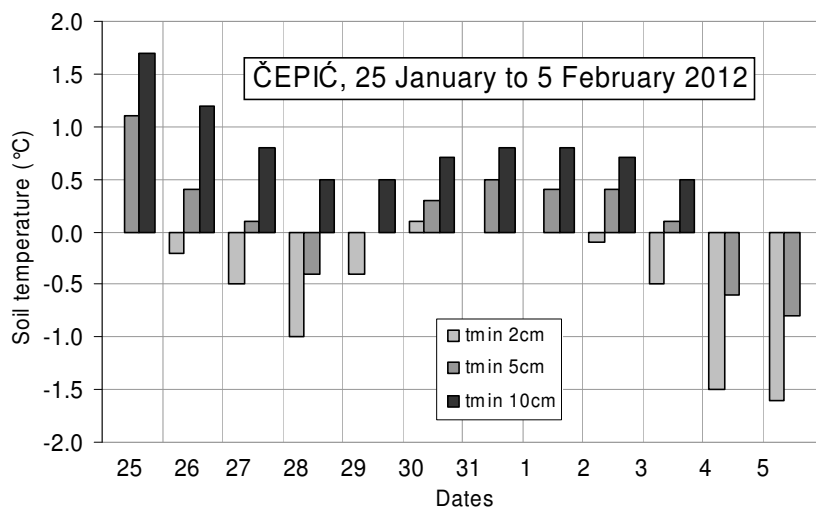
SOIL TEMPERATURE

Soil temperature at different depths measured in the period from 25 January to 5 February 2012

Soil temperature at 2 cm and at 5 cm depth were mainly *negative* from middle January to the end of the second decade in February

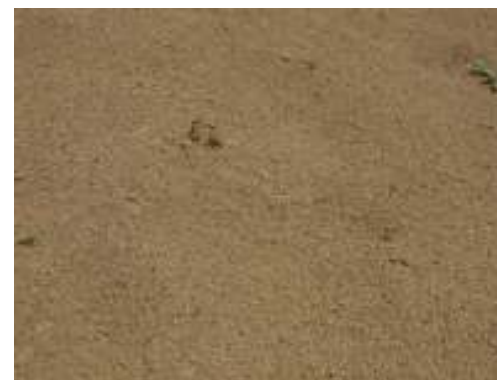
frozen soil surface
